NBSIR 85-3158

Fire Performance of Interstitial Space Construction System

**U.S. DEPARTMENT OF COMMERCE
National Bureau of Standards
National Engineering Laboratory
Center for Fire Research
Gaithersburg, MD 20899**

May 1985

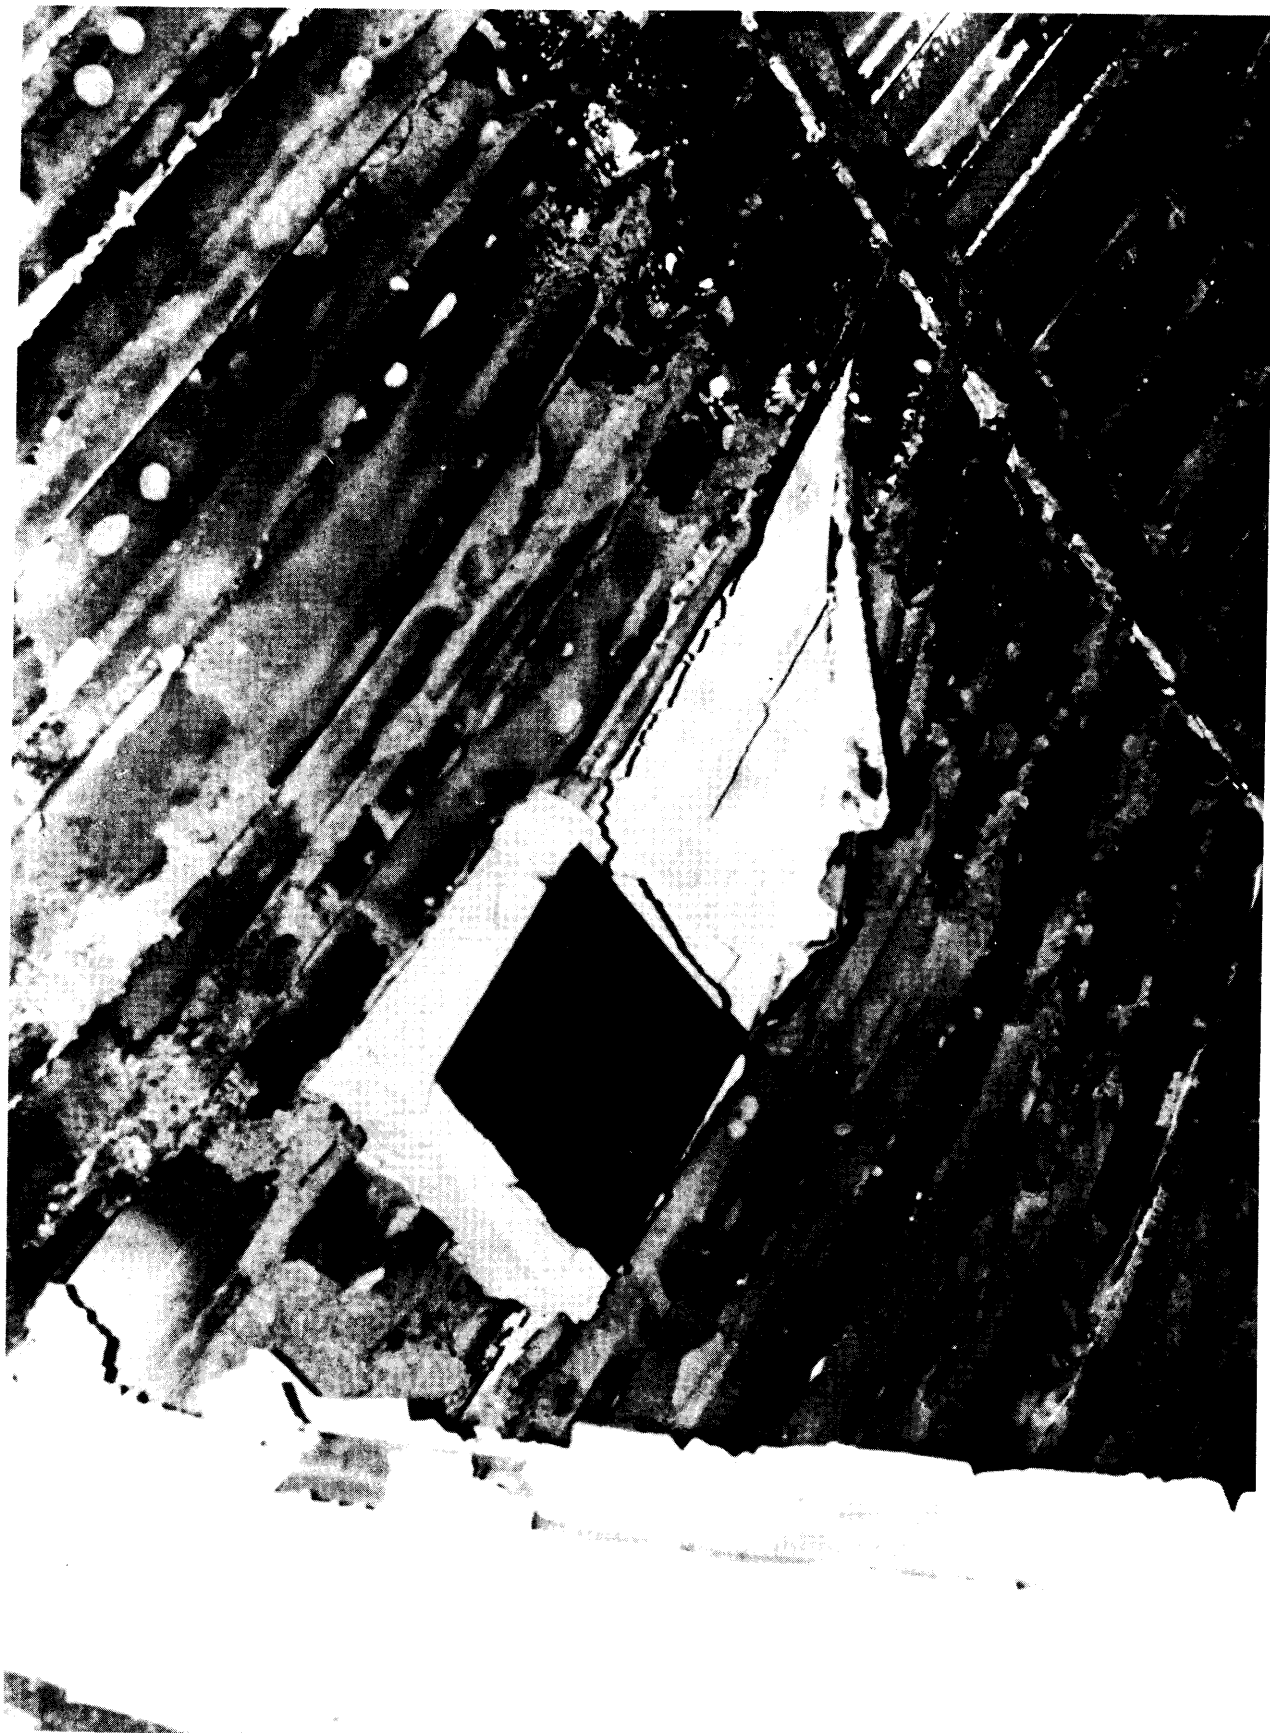
1. Most of the inside layer of gypsum board is still in place around the center column. The metal studs supporting the gypsum board on the column are still in place, figure 24.
2. The pier has spalled on the side exposed to the furnace burner. One piece of concrete approximately 2 inches deep and 6 to 8 inches in diameter has broken away from the pier.
3. The walk-on deck between the purlins has sagged. The metal flooring has dropped away from the concrete floor at one place near the return duct and is sagging approximately one foot below the bottom of the current floor level, figure 24.
4. About 75 to 85 percent of the fireproofing on all of the purlins has dropped off. Only three spots are left where fireproofing remains.
5. All of the firestop material is still in place at the duct penetrations.
6. No signs of burning were noted in the interstitial space.

Figure 24. Photograph showing bottom of walk-on deck after test 1

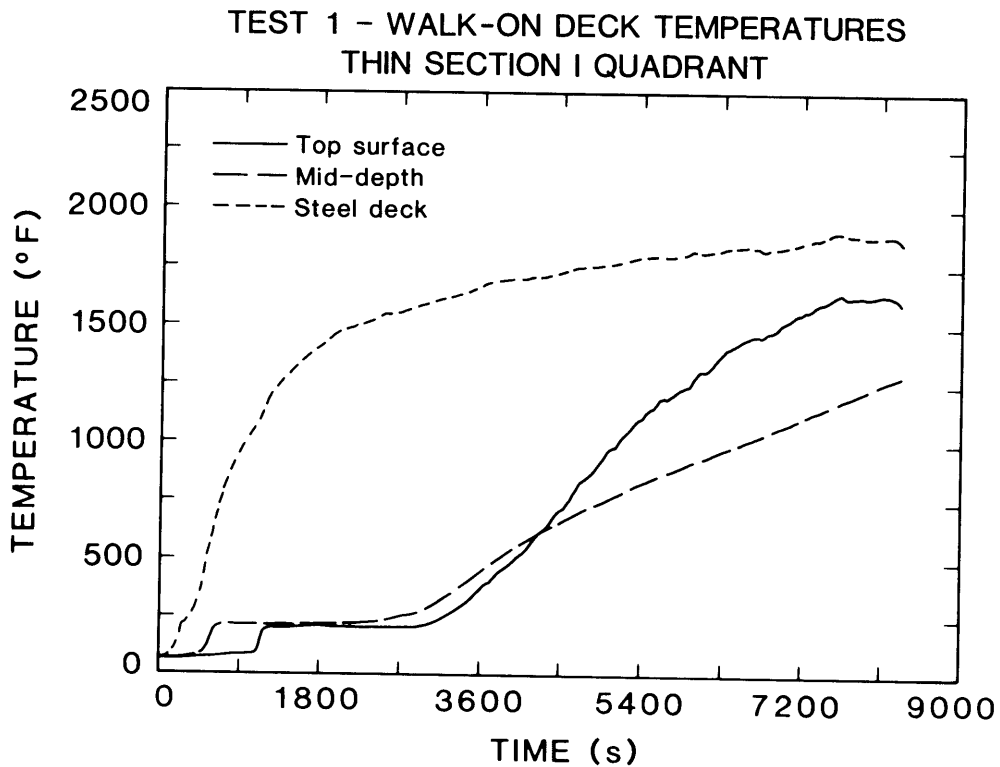
Figures 43 to 46 shows a comparison of walk-on deck temperatures. The high temperatures noted in figure 44 resulted from a crack developing in the walk-on deck near the measurement location. Temperatures were high enough to easily ignite cotton waste, as referenced in NFPA 251. Figures 45 and 46 show temperature rise data for a floor area that did not exhibit major cracking. In this case the surface temperatures stayed below 250°F.

Figure 44. Walk-on deck temperatures thin section quadrant I, test 1

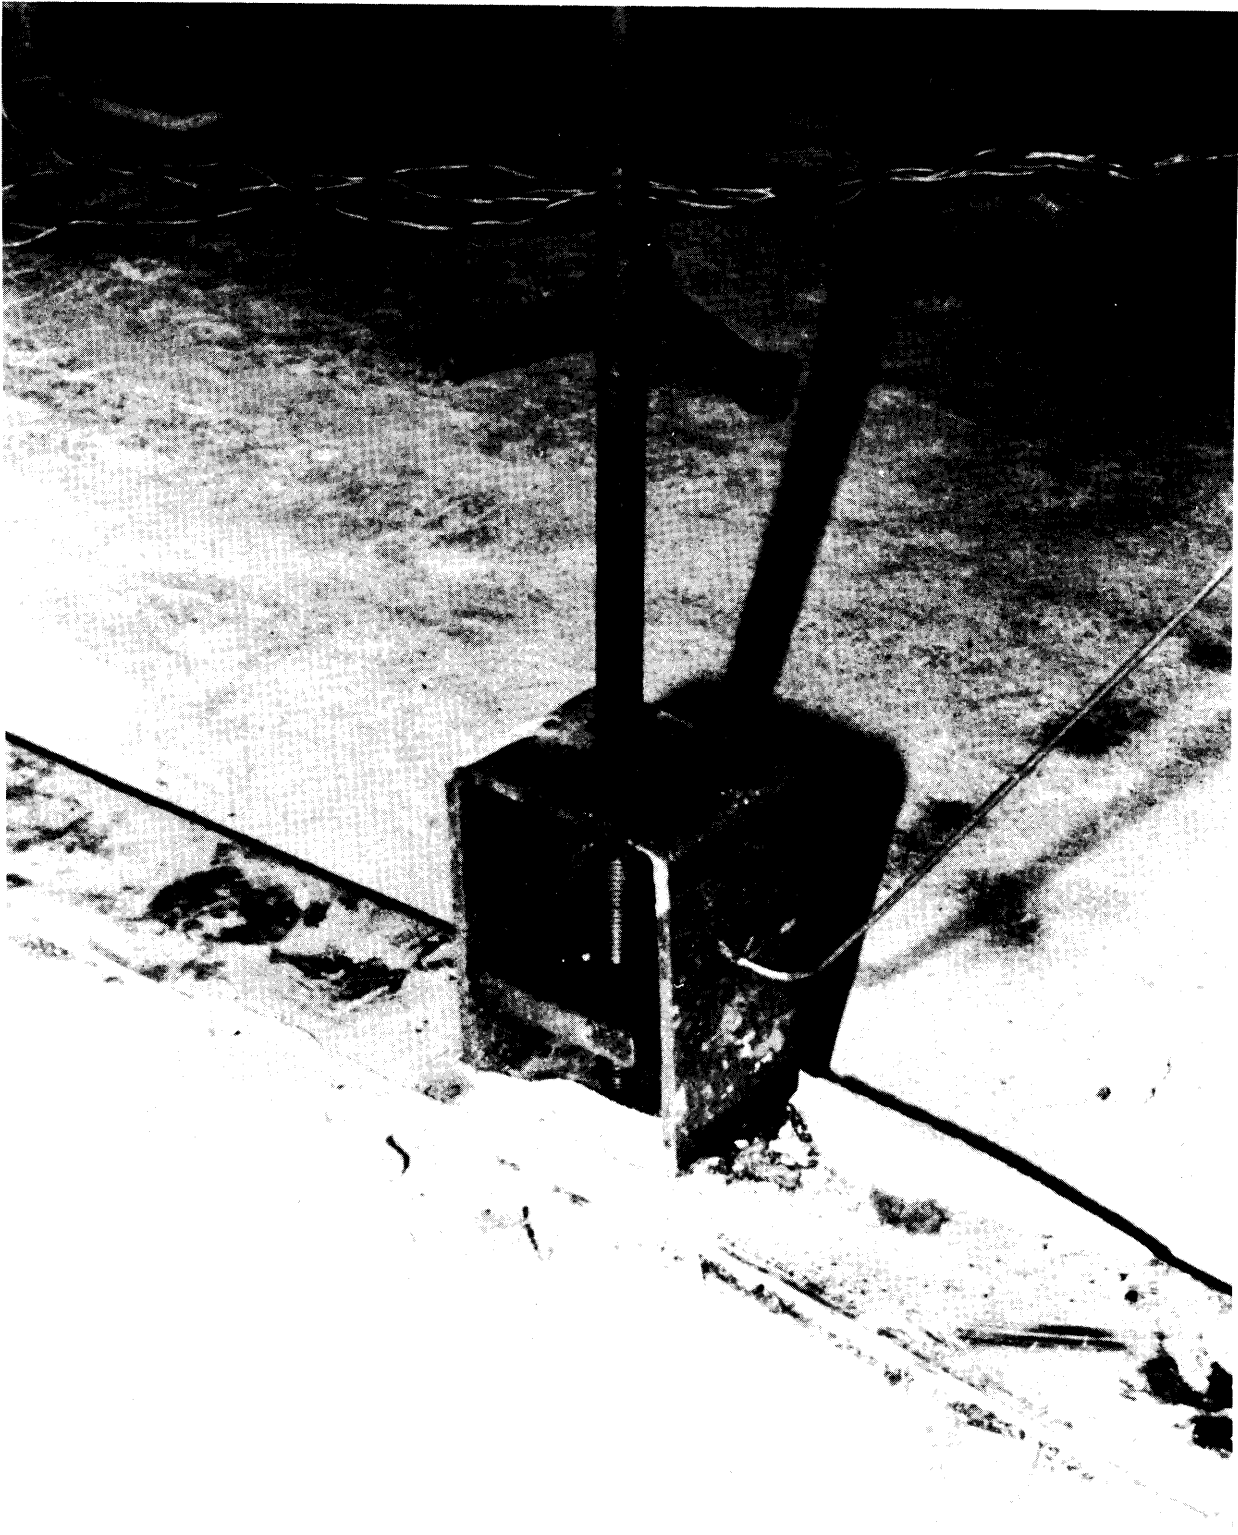
Figure 51. Photograph showing permanent upward set of suspended purlin, test 1

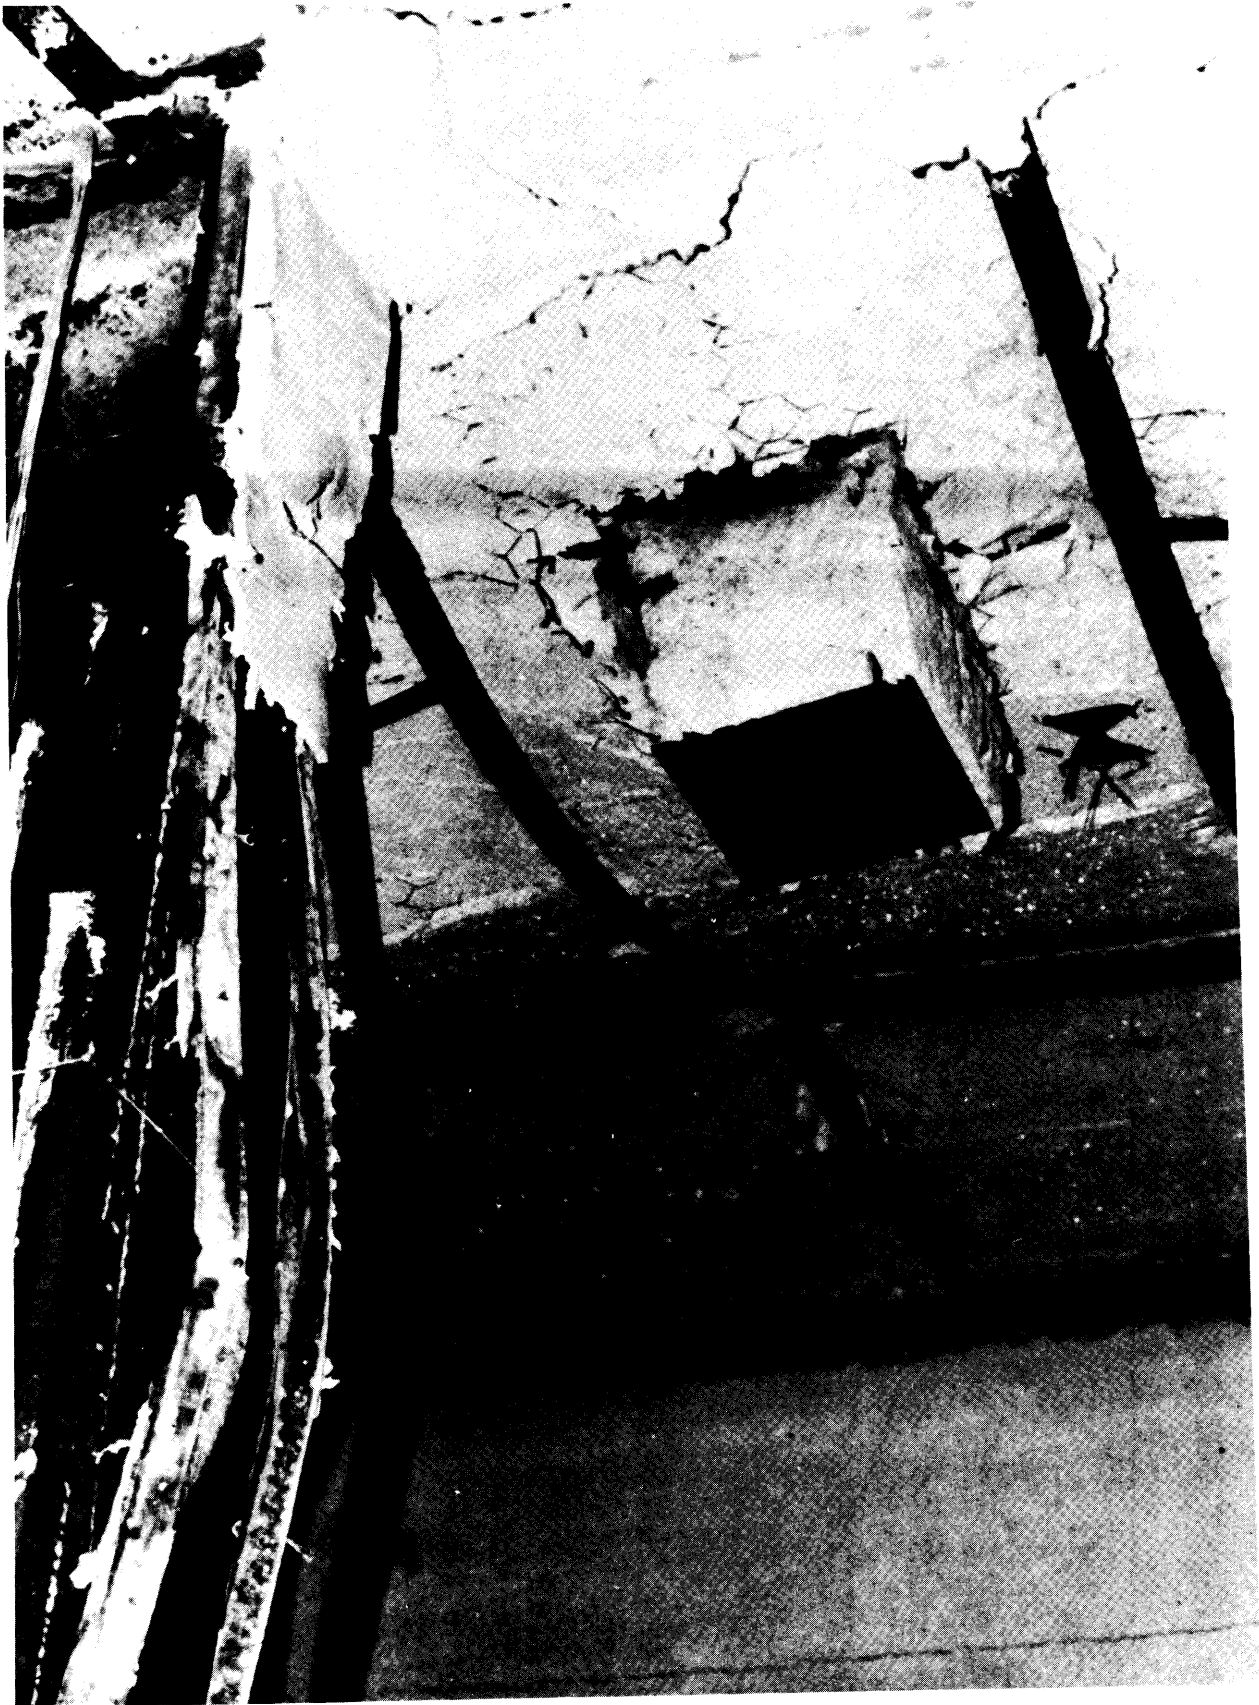
Figure 112. Photograph showing bottom of gypsum walk-on deck after test 3

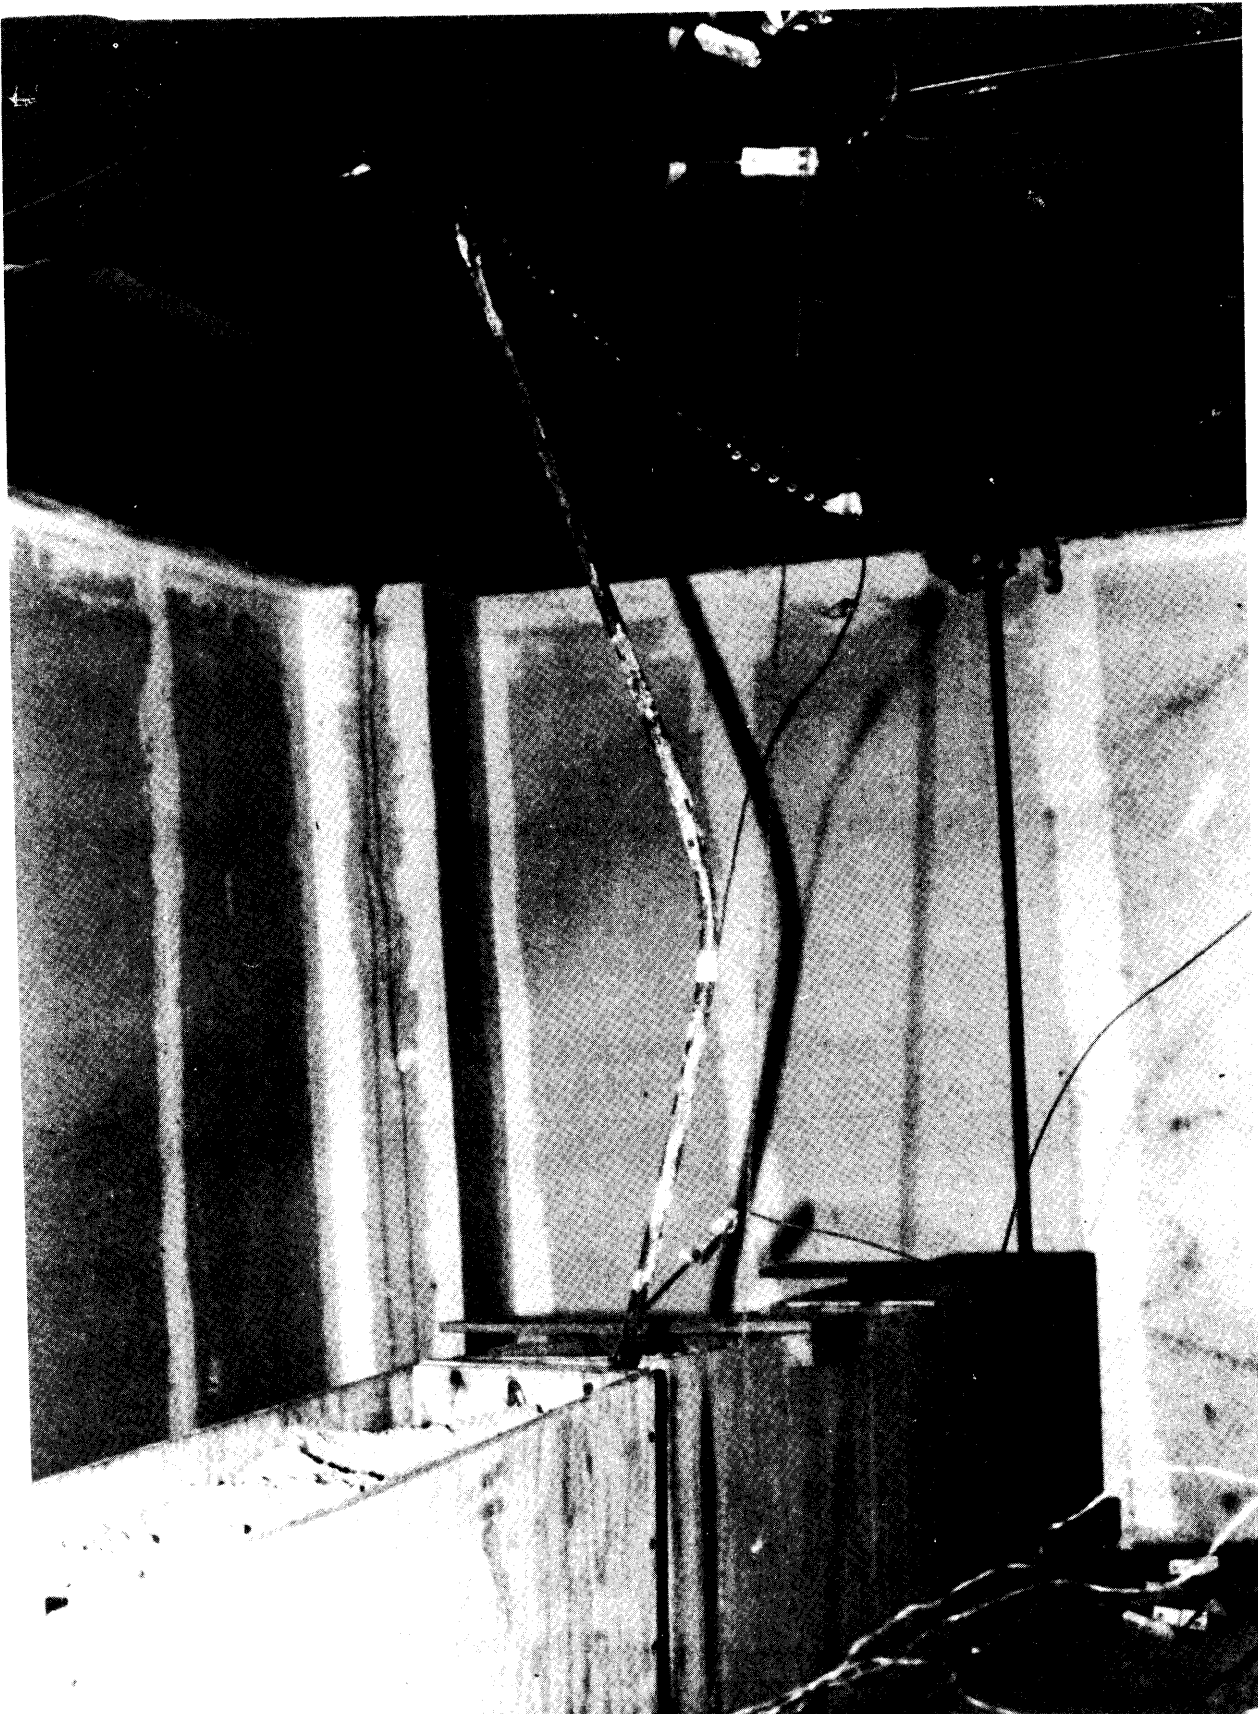
Figure 113. Photograph showing bent suspension rod in interstitial space, test 3
